# Case Study

A major candy manufacturer contacted Controlled Motion Dynamics about an important motion control problem.

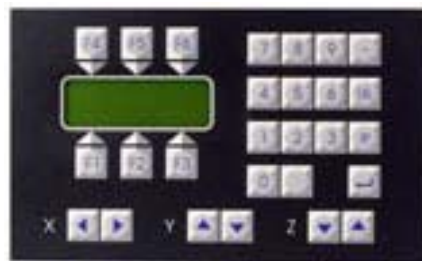
*Keypad design*

- Controlled Motion Dynamics converted the existing program to the Baldor Mint language.
- A Next Move BX II three-axis controller was selected to replace the obsolete controller.
- A new keypad with CAN communication was selected to replace the serial keypad.
- The chain resolver was replaced with an encoder.
- Using the original prints, a conversion print was drawn up to assist the maintenance technician in wiring the new controller into the existing system.
